HYDROGEOLOGIC ASSESSMENT OF  
YORK SANITATION COMPANY LIMITED  
WASTE DISPOSAL SITE NO. 4

Ground Water Protection Unit  
Hydrology and Monitoring Section  
Water Resources Branch

G.M Hughes, Chief  
November 15, 1982

City of York, Ontario

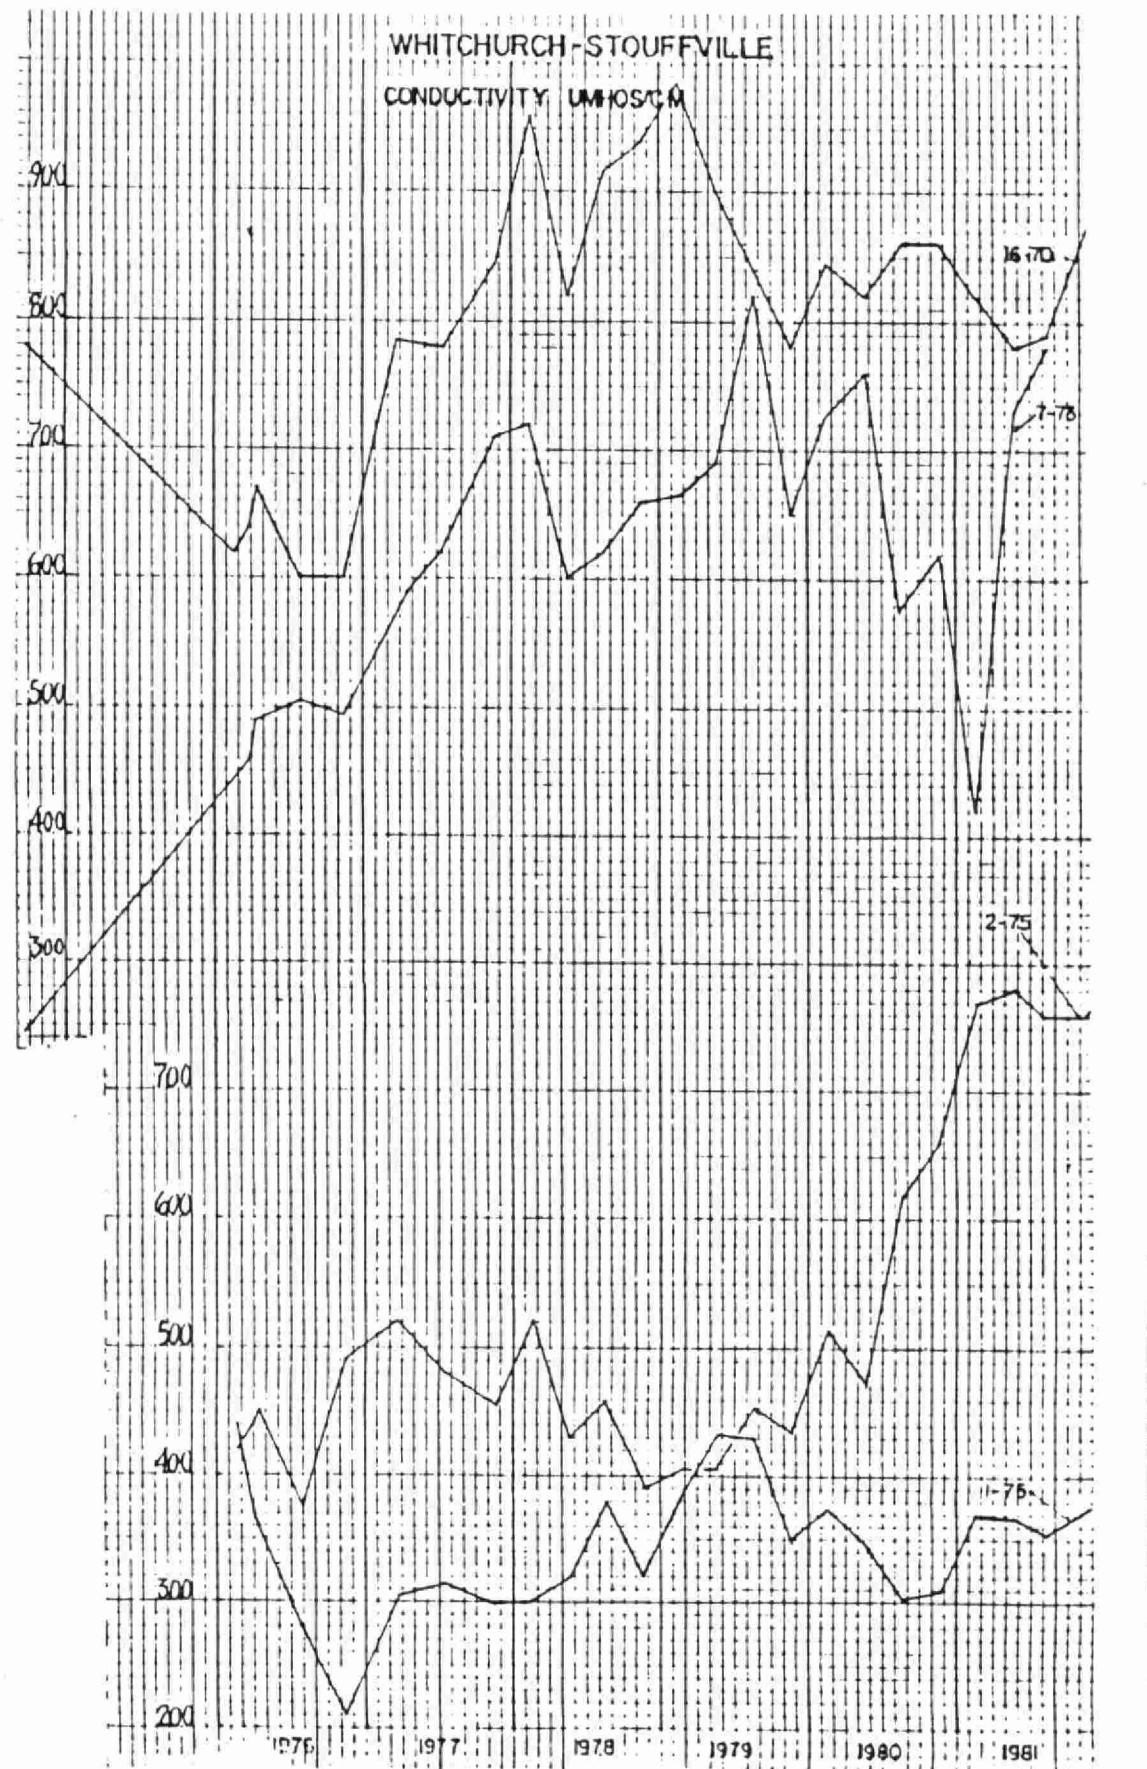
Figure 12 - cont'd - Contaminant Pulses  
 Specific Conductance  
 incl. wells 16-70, 7-73, 2-75, & 1-75.
